Home Inspection Report

St. Augustine, FL, 32092

Inspection Date:
January, 2015

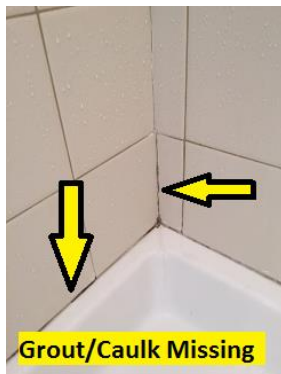
- **Repair:** The supply hose for the left faucet in the master bathroom is leaking.
- **Repair:** The supply hose for the toilet in the master bathroom is leaking.
- **Repair:** Cracked, deteriorated and/or missing shower stall grout and caulk should be replaced where needed.

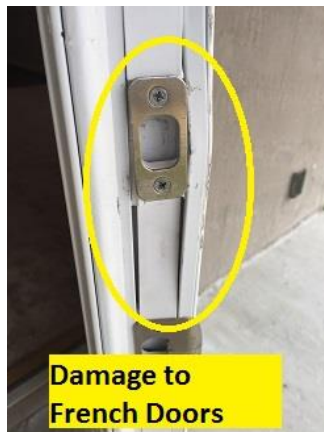
- **Repair:** Damaged French Doors and hardware in the living room to outside should be repaired. Add-on shades are loose and may be hazardous to small children.
- **Repair:** Doors in the main bathroom *and* the front bedroom should be trimmed or adjusted as necessary to work properly.
- **Monitor:** Windows in front bedroom trim damaged from closing window while locks are in engaged position. Plastic trim chipped away.

Damage to French Doors

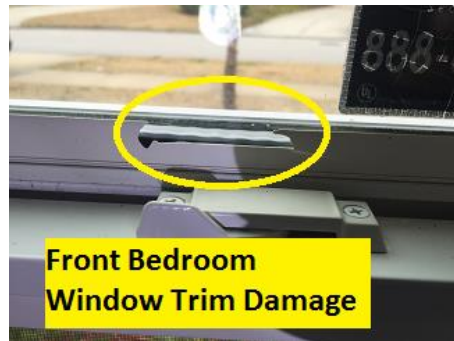
- **Monitor:** Windows in front bedroom trim damaged from closing window while locks are in engaged position. Plastic trim chipped away.
- **Monitor:** The dishwasher appears to have been lacking maintenance and had evidence of erosion.

Front Bedroom Window Trim Damage
